Effect of Fog Seal and Paint Stripe Removal on Chip Seal Behavior in Two Climates

Scott Shuler

Colorado State University
Fort Collins, Colorado

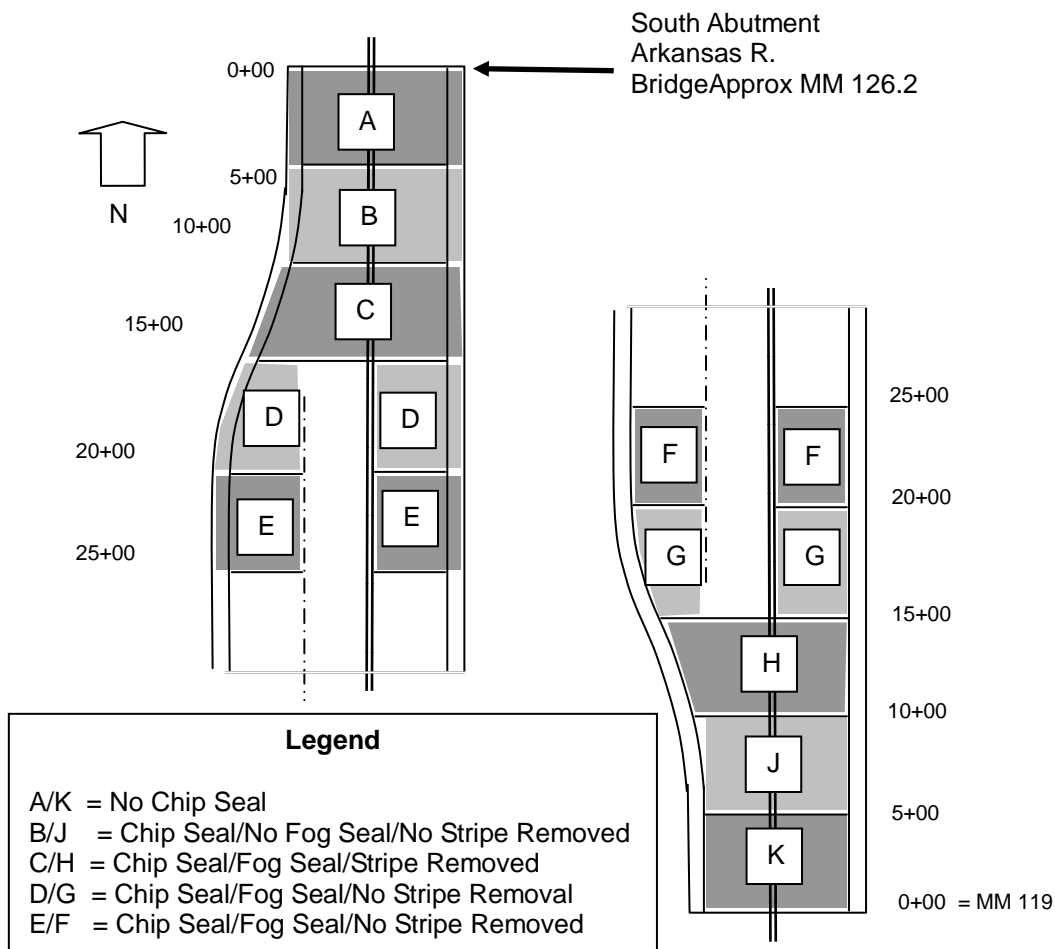
Figure 2. Test Section Locations

The test sections were constructed on US285 south of Poncha Springs, CO. Test sections were constructed 152 m (500 ft) in length in both directions according to the plan shown in Figure 2. One test section of each treatment was constructed with the exception of the chip seal/fog seal/no stripe removed combination which was duplicated.

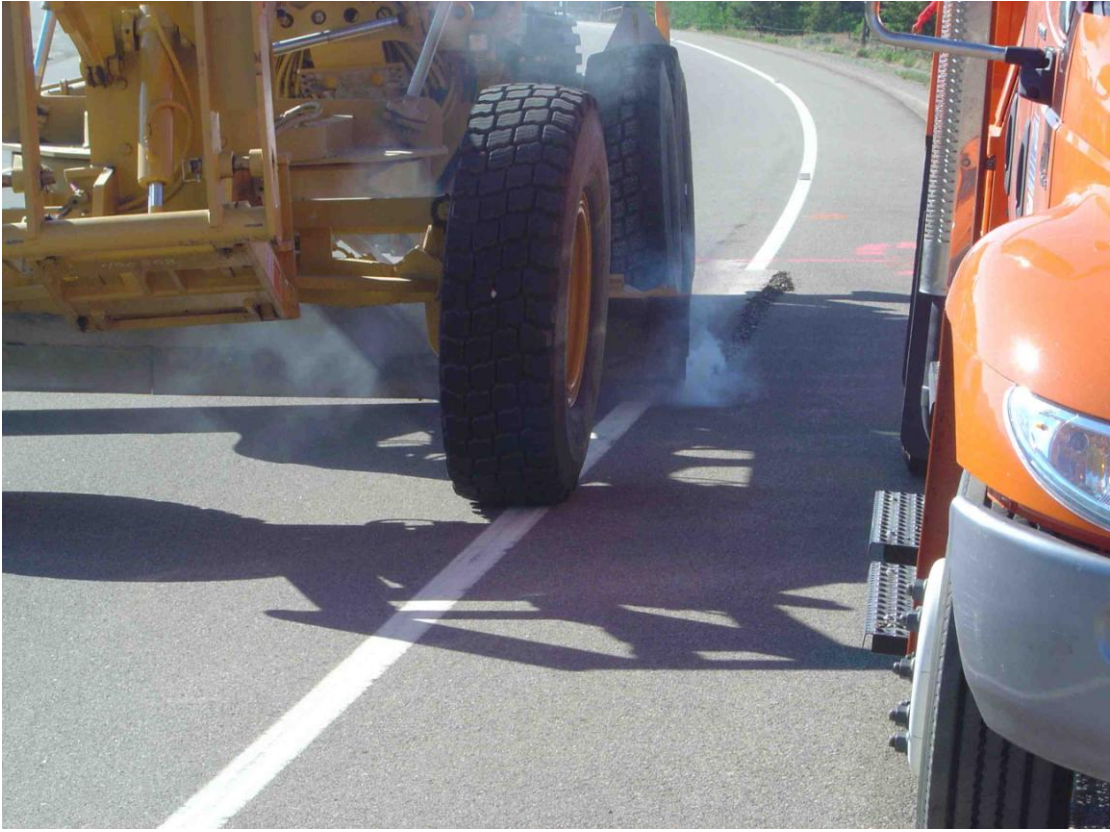
Figure 3. Stripe Removal Process

Removal of the white epoxy paint stripe at the edge of the pavement and the yellow stripe in the center of the pavement was achieved using a conventional motor grader in test sections C and H prior to chip seal operations. The process is shown in Figure 3 and the result of the removal in Figure 4.

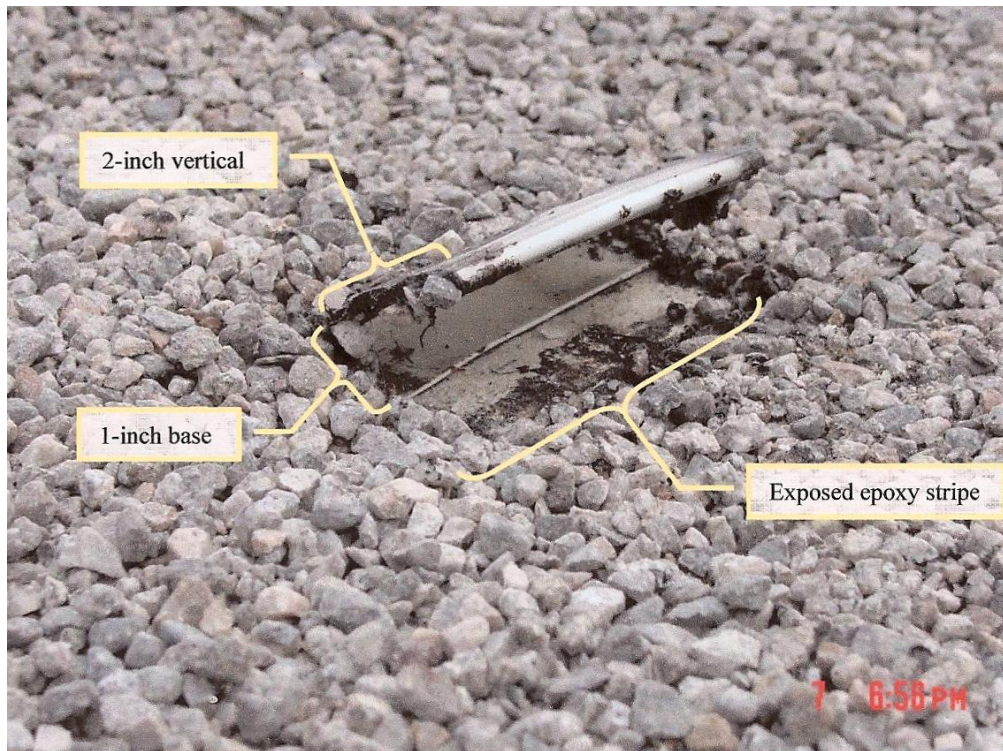
Figure 5. RFPM Shadow Effect

Before a chip seal is constructed a series of elastomeric Raised Flexible Pavement Markers (RFPM) are placed over the epoxy paint stripes. Then, after the seal is placed and the epoxy paint is covered, the location of the stripe can be found for re-striping. It has been suggested (2) that since the RFPM prevents a small area of the pavement from

being sealed as shown in Figure 5 that this ‘shadow’ with little binder and chips could also be a source of future distress due to moisture intrusion and/or snow plow damage.

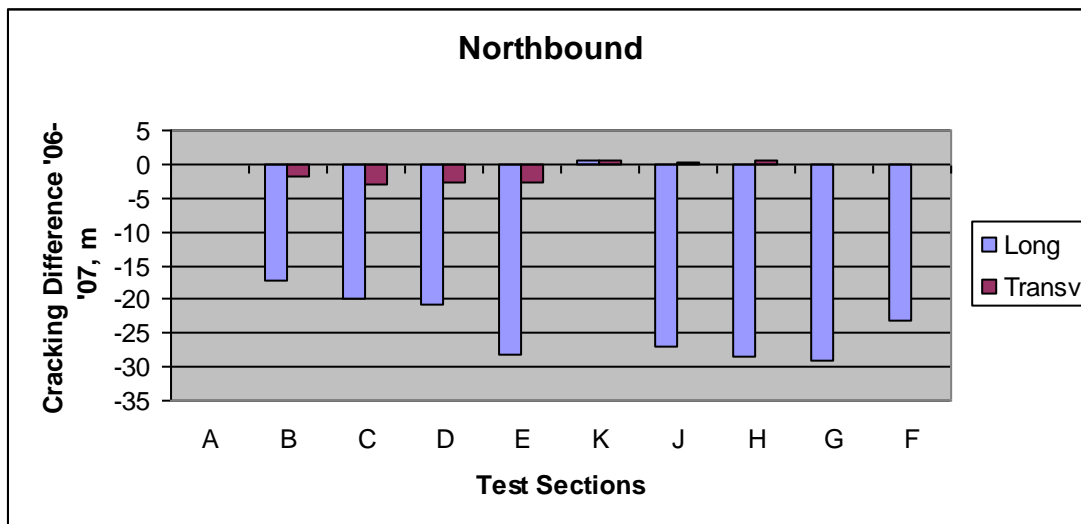
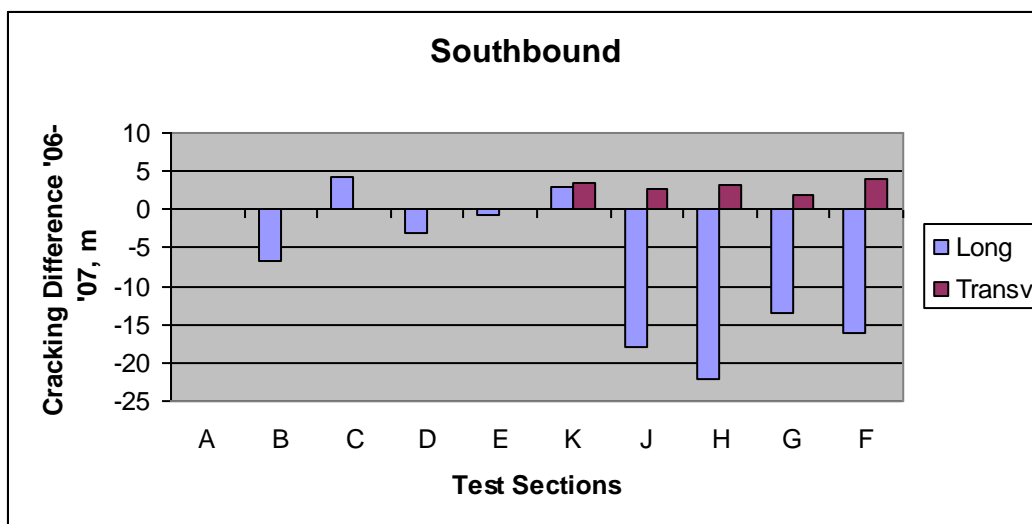
Figure 6. Cracking in Northbound Lane

Figure 7. Cracking in Southbound Lane

The cracking performance shown in Figures 6 and 7 is the difference between the cracks observed in 2006 and those in 2007. Negative numbers on the ordinate indicate less cracks in 2007 than in 2006. For example, there appears to be more transverse cracking in sections F to K than sections A to E for both the northbound and southbound lanes. This may be reasonable since sections A to E are located in the lower elevation portion of the pavement (2081 m versus 2745 m). The lack of fog seal on sections B and J do not appear to have any effect on cracking, to date.

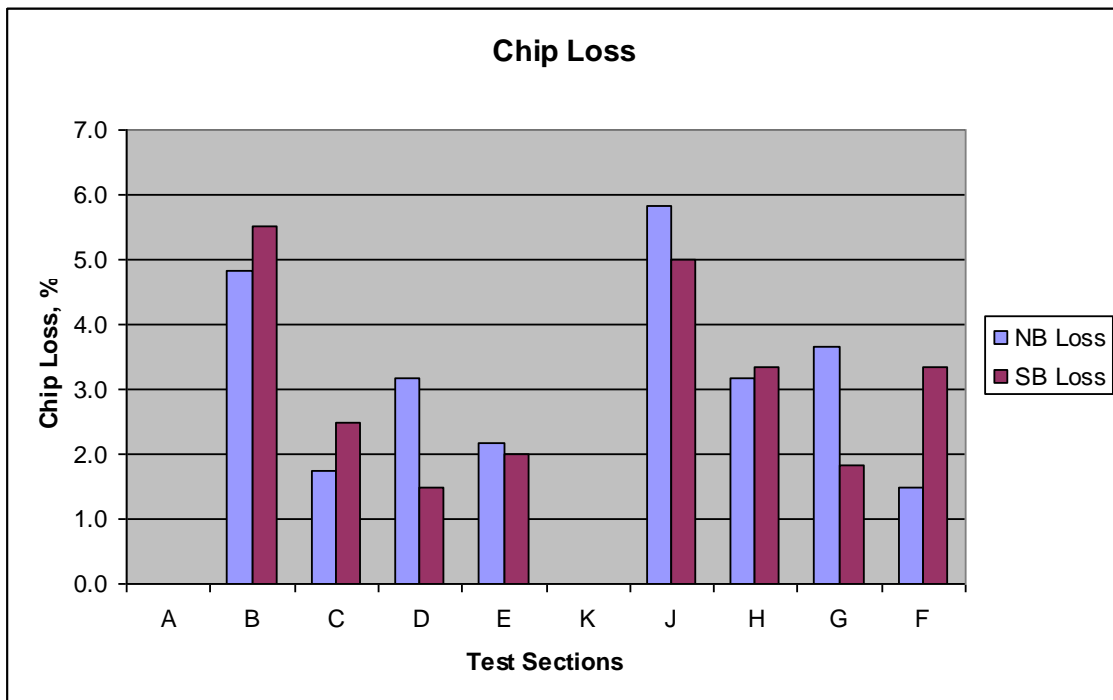
Figure 8. Average Chip Loss

Chip loss due to traffic and/or snow plows is shown in Figure 8. In this case, the lack of fog seal on sections B and J may have contributed to an apparent increase in chip loss (approximately 5 to 6 percent loss) in these sections compared to other sections that had the fog seal applied (approximately 1.5 to 3.5 percent loss).

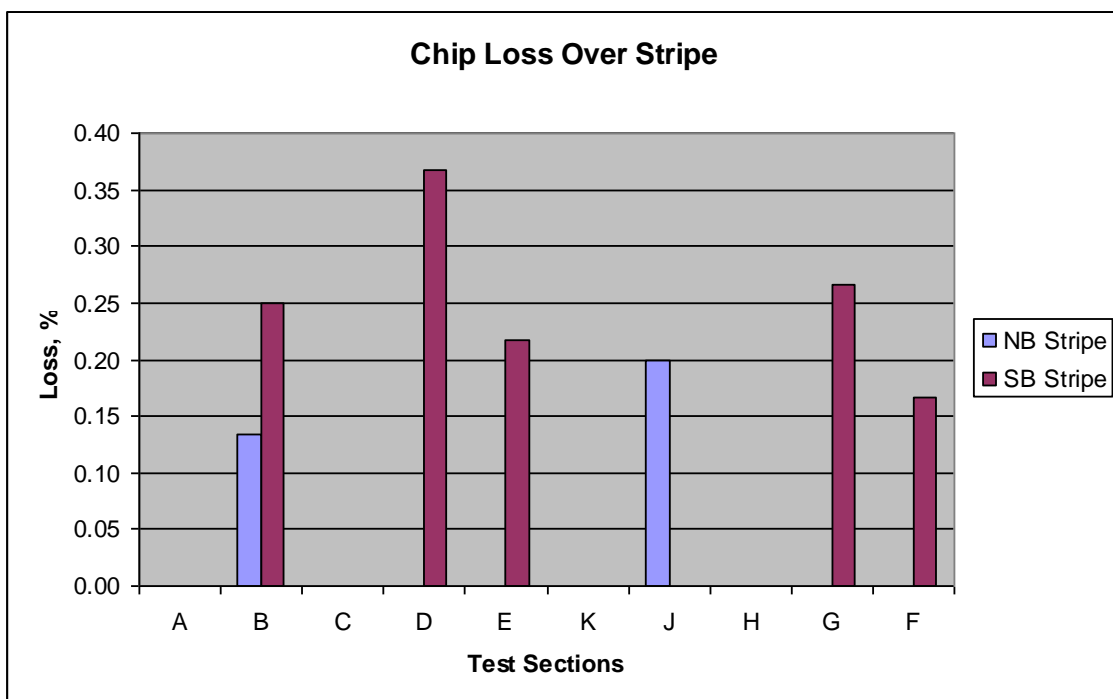
Figure 9. Chip Delamination Over Epoxy Stripe

Chip loss due to delamination of the epoxy paint stripe is shown in Figure 9. There is evidence that removal of the stripe in sections C and H may have contributed to no loss of chips over the paint stripes on these sections as all other sections show evidence of chip loss over the paint stripes of from 0.12 to 0.37 percent or approximately 0.01 to 0.03 square meters. And, although this does not seem like much loss the void remaining makes the surrounding chip seal more vulnerable to snow plow damage and further chip removal.
