Factors Affecting the Appearance of Transverse Bumps in New Asphalt Overlays

Scott Shuler, Ph. D., P. E.
Colorado State University
Fort Collins, Colorado

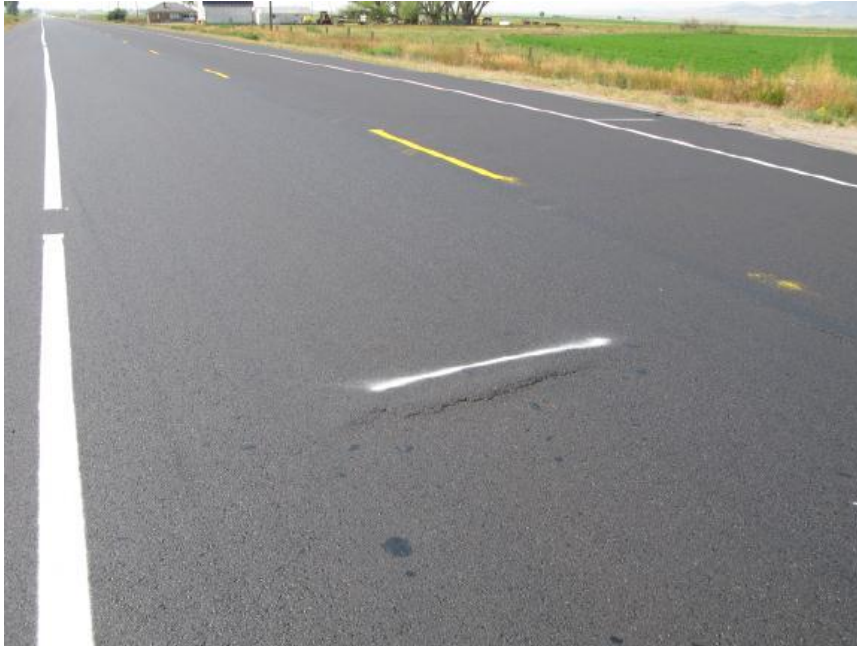
Crack sealing is a common method of pavement preservation. This sealing is done to reduce moisture and debris infiltration into the pavement structure, thereby, theoretically improving pavement performance. During the life of most asphalt concrete pavements overlays are placed to rehabilitate and further extend pavement life. During breakdown rolling of the overlay transverse bumps and cracks have been known to form above and in front of the location where crack sealant was placed in the underlying pavement. It is believed that multiple reasons may cause this phenomenon, including mixture design, climatic conditions, paving and compaction equipment, timing of the overlay with respect to sealant placement, sealant type and pavement grade. The mechanism of bump formation is hypothesized to be the result of the breakdown roller creating a 'bow wave' or shoving of the overlay asphalt during the first roller pass. Heat from the overlay may be transferred down into the substrate pavement and crack sealant. The heated substrate pavement expands and transverse cracks shrink, exuding the crack sealant toward the overlay. The adhesive nature of the crack sealant produces a resistant force to the forward movement of the 'bow wave' in front of the breakdown roller. When the 'bow wave' cannot move forward due to this resistant force, the roller passes over the 'bow wave' creating a bump. The location of this bump is then located slightly in front of the transverse crack containing the sealant as shown in Figure 1.

Figure 1: Transverse Bump in New Asphalt Overlay Placed Over Crack Sealant

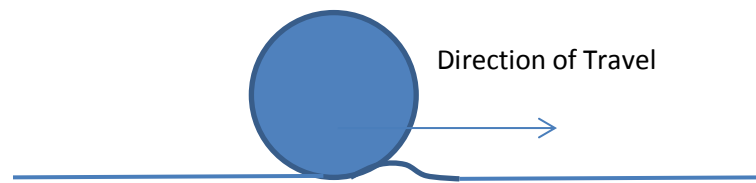
A recent study indicated that the speed of the vibrating steel roller during breakdown influenced bump formation as well as the number of roller passes (Shuler 2009). A study conducted for Colorado DOT (Shuler 2011) found that bumps accompanied by transverse cracking occurred after the crack sealants had been in service for two years in one test pavement. The number of passes of the vibrating steel rollers further exacerbated the presence of the bumps and cracks. The same rollers used in static mode reduced the effect, and pneumatic rollers used for breakdown eliminated the effect. The ambient temperature and temperature of the substrate pavement during construction was reported to have little effect (Shuler, 2011). Transverse bumps over crack sealant on a flat gradient pavement (Shuler 2011) have been reported. However, a relatively large 'bow wave' was also reported during breakdown rolling during this research. A diagram of what is meant by 'bow wave' is shown in Figure 2.

Figure 2: 'Bow Wave' Created by Breakdown Roller

This 'bow wave' could be related to the occurrence of transverse bumps. Therefore, two pavement gradients were introduced in the study reported here in an attempt to create different sized 'bow waves'. In addition, there is anecdotal evidence that tack coat application rate may have an effect on bump creation, and an experiment was designed to test this notion, as well.
