Performance Measurement System for Maintenance of SPF Roofing System: A 4 Year Case Study

Dhaval Gajjar, M.S and Dean Kashiwagi, Ph. D. and Kenneth Sullivan, Ph. D. and Jacob Kashiwagi, Ph. D. and Jake Smithwick, Ph.D.
Arizona State University
Tempe, AZ

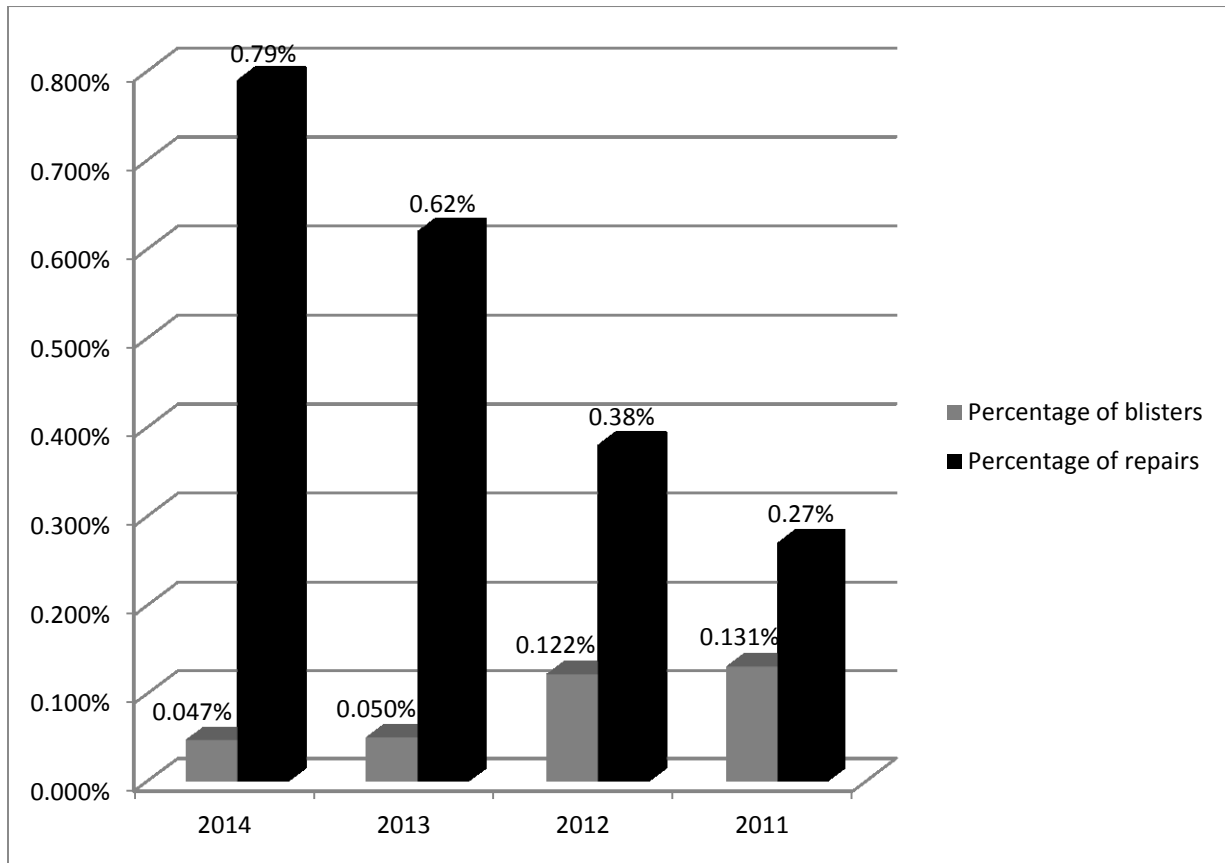
Figure 1. Percentage of blisters and repairs

Since 2011 there have been an increase in the percentage of repairs (of total roof area) and decrease in the percentage of defects (also of total roof area) as shown in Figure 1. The measurement system provided a clear snapshot to the school districts facility manager and help them focus on the roofs that needed immediate preventative maintenance.
