The Cost Effectiveness of Alpha SPF Roofs: Casa View Elementary School Roofing Case Study

Dean T. Kashwiagi, Ph.D., P.E, Dhaval Gajjar, Ph.D., Charles J. Zulanas IV, and Yasir Alhammadi, M.S.

Arizona State University
Tempe, AZ, USA

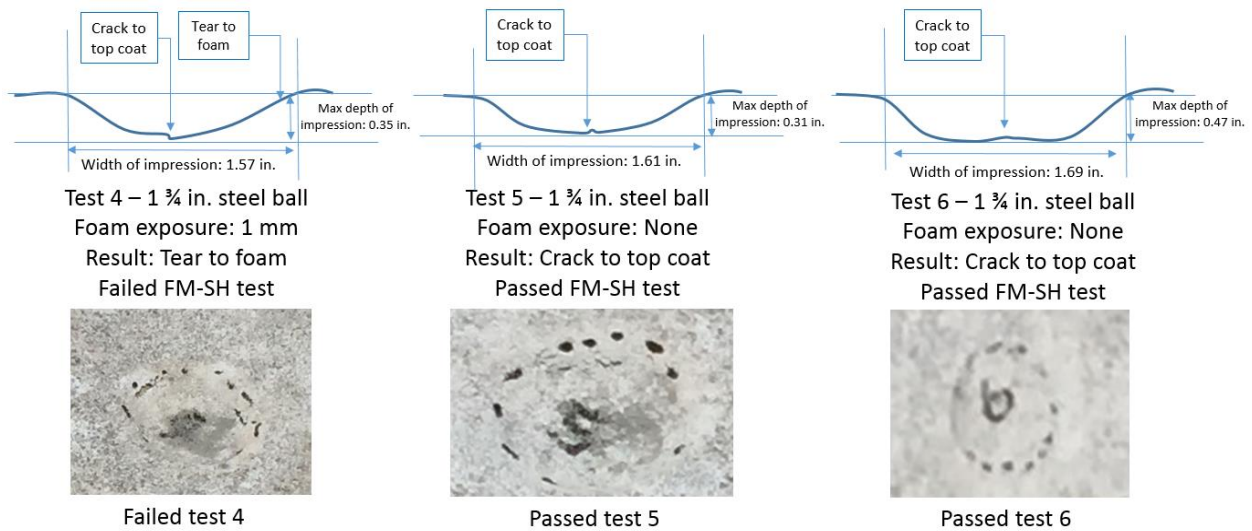
The Casa View Elementary roof passed in 9 of 10 drops. One drop ripped through the coating to reveal the foam. The other two drops ripped only to the top coat.

Number	Result	Pass or Fail	Top Coat (mils)	Base Coat (mils)
Test 1	No Damage	Pass	14.17	38.33
Test 2	No Damage	Pass	20.00	57.50
Test 3	No Damage	Pass	15.50	30.83
Test 4	Tear to Foam	Fail	8.17	21.67
Test 5	Crack to top coat	Pass	6.33	30.67
Test 6	Crack to top coat	Pass	6.50	33.33
Test 7	No Damage	Pass	10.33	40.83
Test 8	No Damage	Pass	13.00	47.50
Test 9	No Damage	Pass	16.67	45.83
Test 10	No Damage	Pass	14.00	48.33

During the 1 3/4 inch steel ball hail tests, the researchers found that only 1 out of 10 tests failed. On a 29 year old roof that was far past its warranty, the roof continued to show proven performance. Out of the 9 tests that passed, only 2 of those tests cracked to expose the top coat. All others had no damage or exposure to top coat or to the foam.

Figure 1: 1 ¾ in. hail tests that tore to the foam or cracked to expose the top coat.

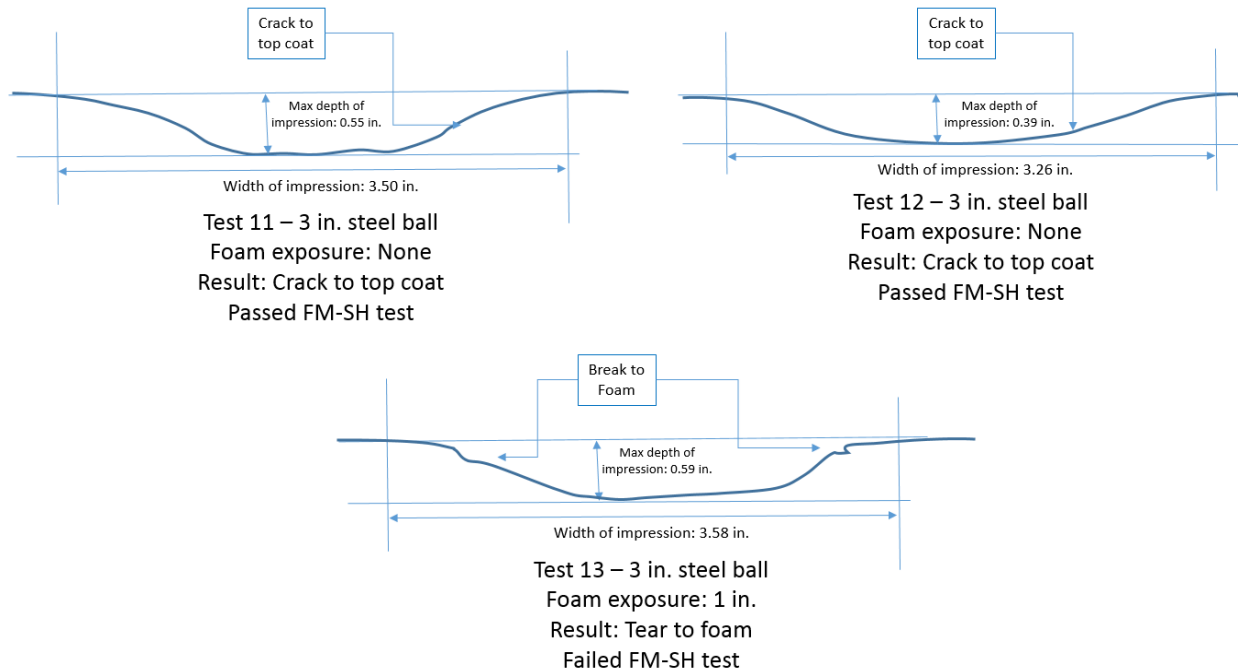
Additionally, the researchers dropped a 3 inch diameter steel ball three times from the same height of 17 feet 9 inches. One of the steel ball drop damaged the coating to the SPF. The other two drops resulted in tears to the top coat. This far exceeds the FM SH test requirements.

Number	Result	Pass or Fail	Top Coat (mils)	Base Coat (mils)
Test 11	Crack to top coat	Pass	15.83	35.00
Test 12	Crack to top coat	Pass	9.00	45.00
Test 13	Break to Foam	Fail	8.00	30.00

During the 3-inch steel ball hail tests, the researchers found that 1 out of 3 tests failed. On a 29-year-old roof that was far past its warranty, the roof continues to show proven performance. Due to the heavy impact, the ball caused the roof to crack to topcoat on the two tests that passed the test. The average width of the dent was very similar on all of the tests, averaging to about 88 mm. The average indent size was about 12 mm, due to the size of the ball being dropped.

Figure 2: 3-inch. hail tests that broke to the foam or cracked to expose the top coat.

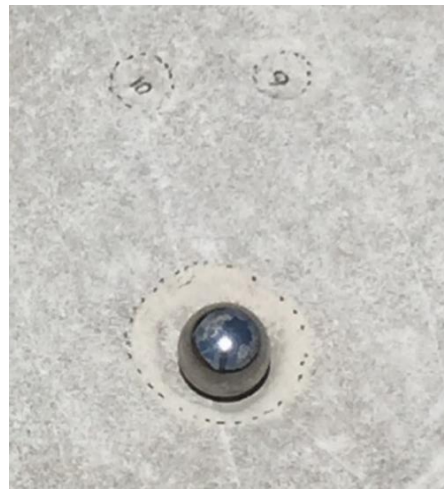
Figure 3: Passed dent from 3 in. steel ball test compared to dents from a 1 ¾ in. steel ball tests
