# **Evaluation of Excavation-Induced Surface Settlement and Effectiveness of Cement Grouting in Mitigating Building Deformation**

Key words: cement grouting, foundation excavation, surface settlement, building deformation

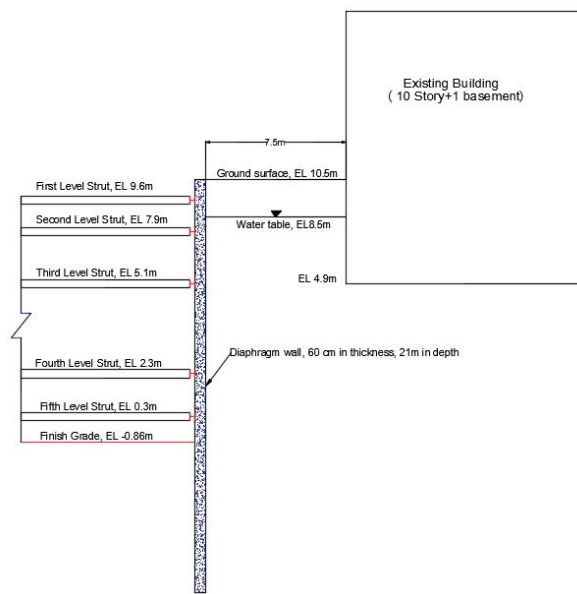
Figure 1: Cross sectional view of excavation site and the existing building

An open-cut excavation was constructed in a densely populated area. Based on a construction layout, a braced-cut construction method was used and the job site was only 7.5 meters away from an existing 12-story building. Diaphragm walls (60 cm thick and 21m deep) were designed as a soil shoring structure to resist lateral earth pressure as well as high water pressure. Five levels of strut and wale were installed against both sides of diaphragm wall. The excavation finish surface was designed at a depth of 11.4 m below the ground surface. A cross sectional view of the entire site and the adjacent building is displayed in Figure 1. According to the soil boring report and soil logs (Table 1), the groundwater table was detected below ground surface between -2.0 m to -3.0 m. In addition, a 5-meter thick silty sand is located between 5.5m and 10.5 m beneath the surface, provided water pressure is significant against the diaphragm walls. Therefore, it was essential to operate dewatering during the excavation construction. Because the excavation surface had to be kept in a dry condition, the existing ground water table must be lowered at least 1 meter below the excavation surface (-12.5 m below the ground surface). Well points associated with multiple wells dewatering system were used. These wells were connected to pipes surrounding the excavation site. By using the dewatering system, ground water was pumped out of the job site to the nearby creeks. Based on Schroeder et al. (2004), lowering of the ground water table by 3 m (10 ft) is approximately equivalent to imposing a surface load on the soil of 30 MPa (624 psf). It was obvious that potential surface settlement might have been an issue that could significantly impact excavation safety.

shown in Figure 1, there is a 10-story building nearby the excavation site that might have potential damage due to excavation induced settlement. As mentioned previously the diaphragm wall (60cm in thickness, 21 m in depth) connected with five levels of struts (Figure 1) were designed as excavation shoring support. Given the soil report in Table 1, these are two layers of the soil located between -5.5 m to -16m where soil properties were expressed as follows:

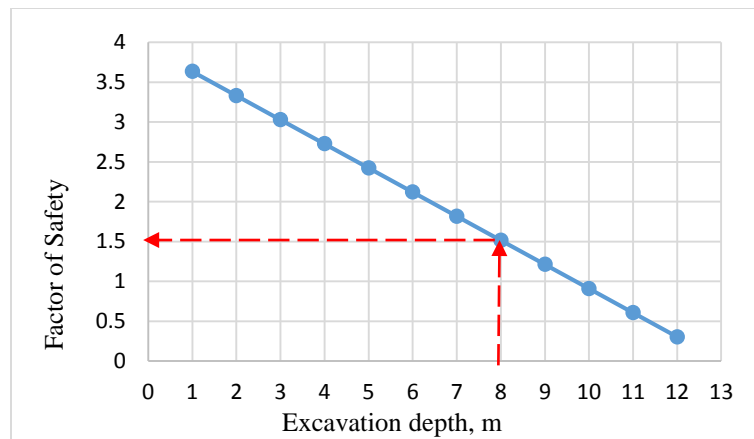
Figure 5: Mathematical relationship between FS and excavation depth

A mathematical relationship between a depth of excavation and a FS is shown in Figure 5. Obviously, a critical excavation depth for foundation operation is found at 8 meters below the surface. According to the soil logs in conjunction with geotechnical engineering analysis, when the foundation is excavated at a depth of 11.57 m, a FS is determined as 0.34 which is significantly less than 1.5. The analysis result indicated that uplifting would be more likely occurred during excavation.

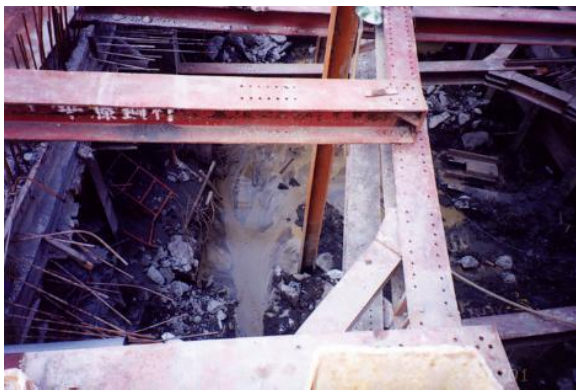
*Figure 6: Groundwater flooding on finished surface*

After completion of excavation, groundwater flooding was observed on the finished surface as shown in Figure 6. This observation was evident to an uplifting event. When uplifting occurred, soil particles at the excavated and its surrounding areas would be reoriented, resulting in a surface settlement and subsequently causing an adjacent building to tilt. After the building started leaning, the contractor installed a tiltmeter mounted on the basement wall of the existing building to monitor the deformation of building due to excavation-induced surface settlement. The angular

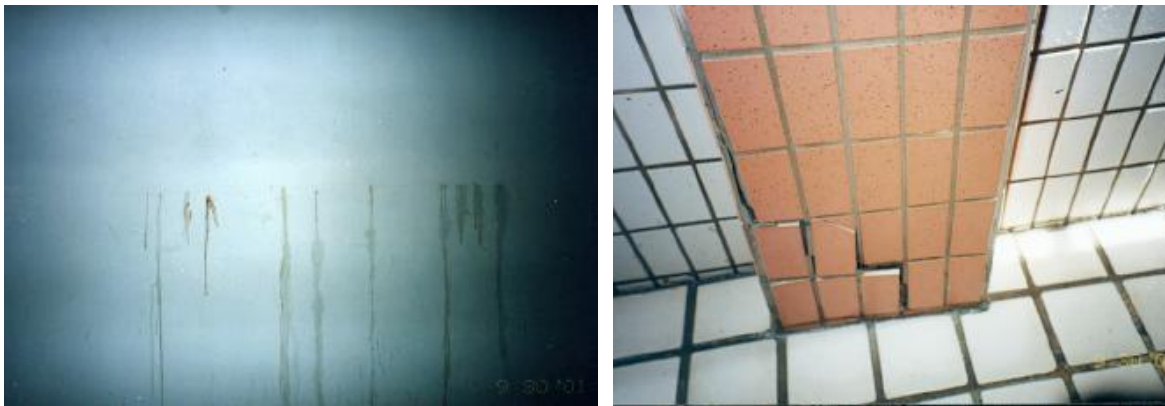
*Figure 7: Water leaking due to horizontal crack in a basement wall (left) and a column (right)*

distortion of tiltmeter was recorded at a radian of  $1/480$  exceeding the tolerable settlement of buildings ( $1/500$ , for safe limit for no cracking of buildings) as recommended by (Bjerrum, 1963). This measure indicated the existing building has leaned towards the excavation site and cracking of building might have occurred. On the following day, cracks were noticed on the wall of the basement of the adjacent building as shown in Figure 7. It was believed that the foundation of building settled due to excavation-induced settlement and soil uplifting. To prevent the building from being further tilted, cement grouting was immediately scheduled and used to fill underground voids and in an attempt to lift up the settled building foundation. The cement grouting was set at a pressure rate of  $5-10 \text{ kg/cm}^2$  and the grouting rate was set at  $30 \text{ liter/min}$ . The decision to grouting pressure was made based on the concern that a higher grouting rate could have undermined the confining effect of soil, diaphragm walls, and the existing foundation. Cement paste was injected into the soil and penetrated slowly to fill voids. The target improvement areas were determined at a layer of silty sand and a part of clay ranging from  $-5 \text{ m}$  to  $-12 \text{ m}$ . The mix design of cement grouting was determined at a ratio of  $1:1:0.6$  (cement: water: nature sand) with a designed unconfined compressive strength ( $q_u$ ) of  $30-40 \text{ kg/cm}^2$  ( $285-430 \text{ psi}$ ). The cement grouting was injected at an interval of  $4 \text{ meters}$  along the sidewalks in front of the damaged building. Figure 8 illustrates the arrangement of cement grouting work.

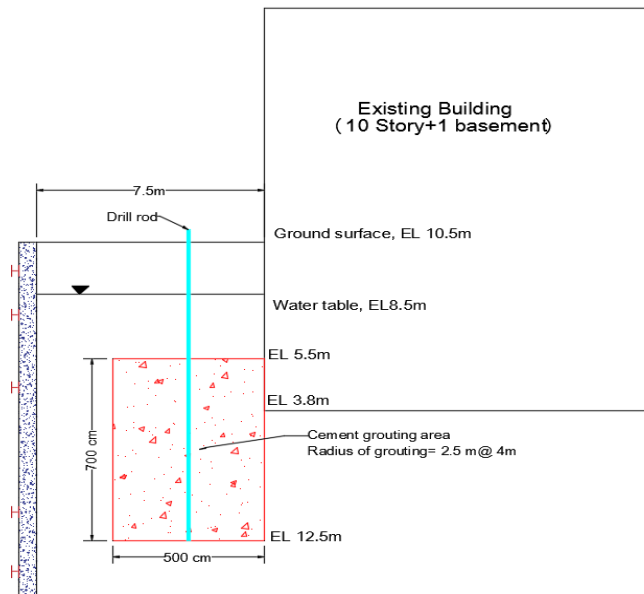
Figure 8: Cement grouting arrangement and layout

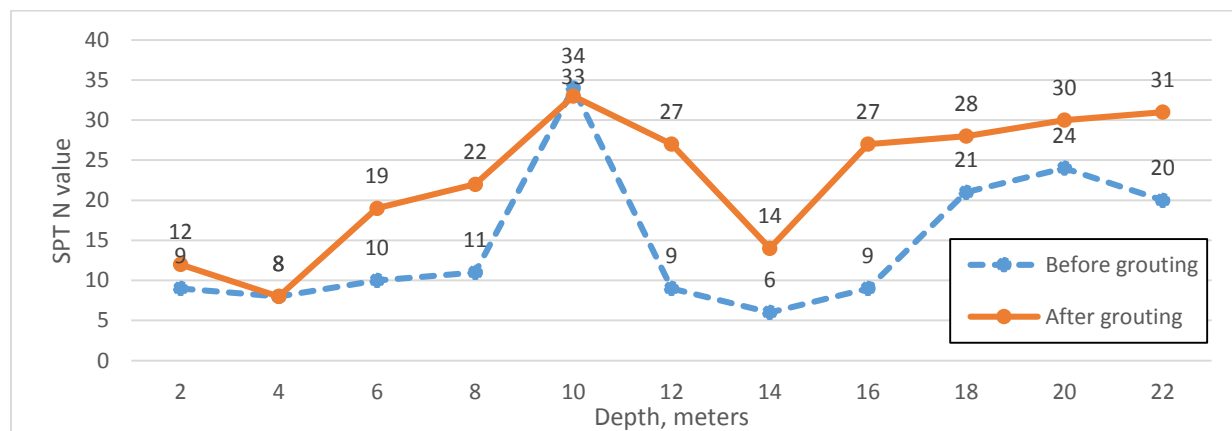
Figure 9: Effectiveness of cement grouting

To evaluate the effectiveness of cement grouting in mitigating excavation induced surface settlement and tilting building, a series of standard penetration test (SPT) were performed. SPT samples were collected from the range of  $-2 \text{ m}$  to  $-22 \text{ m}$ . Based on boring data, depths between  $-8$  to  $-12 \text{ m}$  were specifically monitored as this range was identified as critical area for uplifting event. Figure 8 shows the improvement of soil properties before and after cement grouting. It is noticed that SPT N values increased from  $11$  to  $22$  at a depth of  $8 \text{ m}$ , and from  $9$  to  $27$  at a depth of  $12 \text{ m}$ . SPT N

value was not significantly improved at a depth of 10 m. However, the soil properties between 9-10 meters shows the SPT N value was 33 and 34 before and after grouting meaning that the soil was stiff and consolidated at this range. Apparently, shear strength of the soil between depths of 2 m to 22 m increased. Four control points were also installed in front of the damaged building before cement grouting and were used to monitor the progress of surface settlement as well as building tilting. Table 2 depicts the effectiveness of cement grouting in mitigating excavation induced settlement. All surface settlements measured from the four control points indicated the surface was lifted up ranging from 1 mm to 6mm.

Furthermore, angular distortion was recorded on October 22 at 1/403 (radian) as compared with the initial 1/481 (radian) measured on September 24. The tilting situation of building seemed to be under control and did not show significant angular distortions. Field observations were implemented during cement grouting to closely monitor building deformation. Until completion of cement grouting, no further settlement was observed and the tilting of building had been terminated. The effectiveness of cement grouting in mitigating surface settlement and building deformation was significant. It should be noted that due to information sensitivity, the exact location and date of the event must be remained anonymous. Due to the limited information of field measurement, lateral displacements were not measured to compare the difference between analysis results and actual data.
