Estimation Tool for Residential Corrosive Drywall

Corrosive drywall is a gypsum-based plasterboard that was manufactured in China and contains elemental sulfur and strontium. The drywall emits reduced sulfur gases in the chemical forms of hydrogen sulfide, carbonyl sulfide and carbon disulfide. These three gasses have been linked to the corrosion of metal components in homes including electrical wiring, refrigeration coils and fire safety devices creating a number of life safety issues. The import of Chinese drywall into the U.S. has been occurring since 1999. Estimates place the number of affected homes up to 38,000 and nearly two-thirds of those may be in the state of Florida. Several remediation protocols, including an interim protocol issued by the federal government, include the removal of all corrosive drywall from the home. This difficult and costly procedure will have a wide range of emotional, economic and environmental impacts. This paper presents the issues with corrosive drywall and provides Floridians an estimating tool to help gauge the financial burden of undertaking the interim federal remediation strategy.

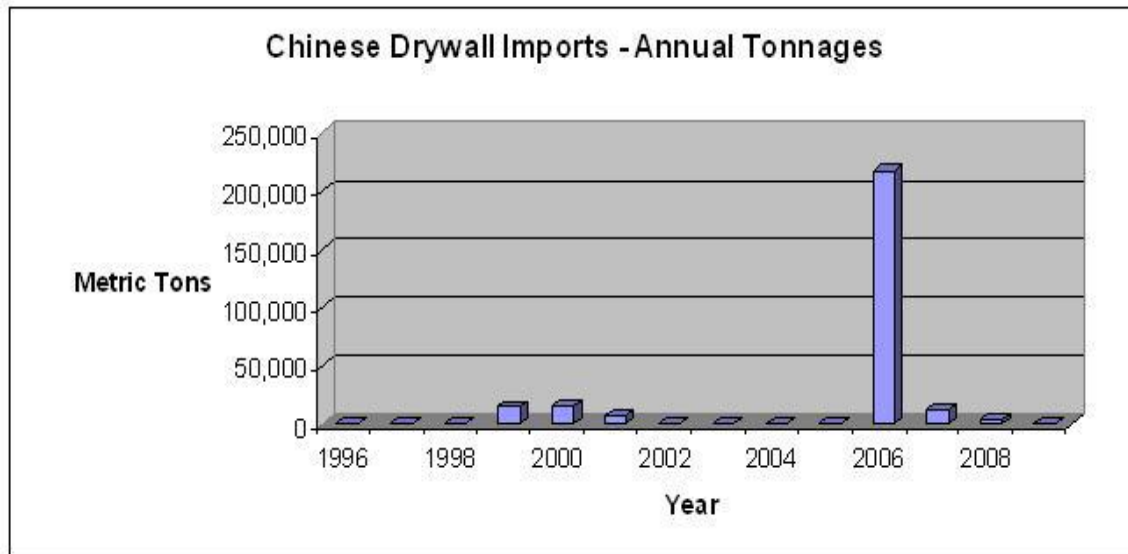
Figure 1. Total metric tons of imported Chinese drywall by year

The full impact of the corrosive drywall problem in the U.S. is still emerging. As of May 7, 2010, the U.S. Consumer Product Safety Commission has received 3,082 reports from 37 different states, as well as the District of Columbia, Puerto Rico and American Samoa alleging that drywall manufactured in China is threatening health, corroding certain metal components in the home, or both (U.S. Consumer Product Safety Commission, 2010). These figures do not include cases that are reported at the state or local levels. Some estimates put the number of affected homes at 60,000 (Schmidt, 2009). Regardless of the final count, there is a significant emotional, economic and environmental impact involved in identifying and ultimately remediating the homes that contain corrosive drywall. Figure 1 illustrates that the quantity of imported Chinese drywall spiked in 2006 at nearly 218,100 metric tons (Crangle, 2009).

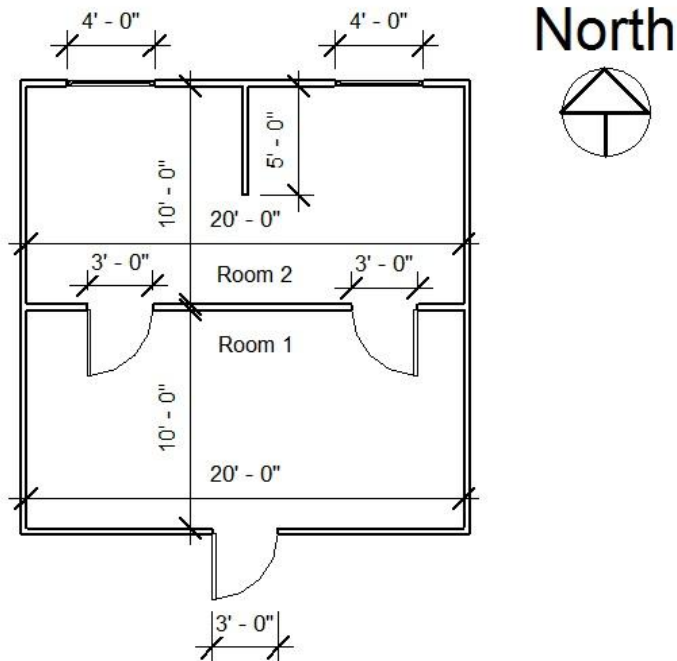
The overall dimensions of the rooms are shown in Figure 5, the building floor plan. The wall with the two windows is on the north side of the building and the entrance is found on the south side. All three doors are 3 feet wide and

both windows are 4 feet wide. The interior dimensions of both rooms are 10 feet long by 20 feet wide. The interior partition that splits the north room is 5 feet in length. The south room is named Room 1 and the north room is named Room 2. For the model, all doors are 7 feet in height, windows are 2 feet in height and the building walls are 8 feet in height.

Figure 5. Floor plan of the house used to test the Estimating Tool
