# Using Laser Scanning to Determine As-Is Building Conditions

**Justin M. Reginato, Ph.D., P.E., LEED Green Assoc.**  
California State University, Sacramento  
Sacramento, CA

**Key Words:** Laser scanning, as-built drawings, as-is conditions, clash avoidance, constructability

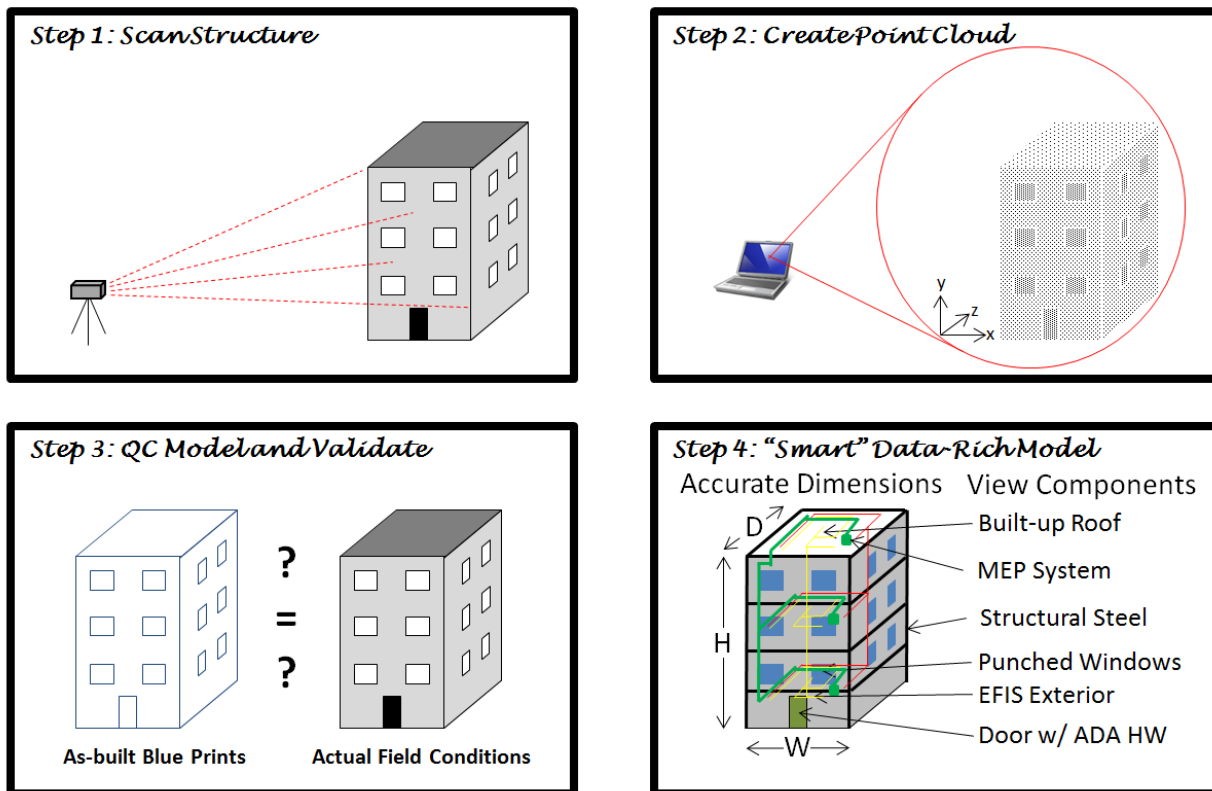
The basic process associated with laser scanning is shown below in Figure 1. Laser scanning itself comprises of steps 1 and 2. Once the point cloud is created, it can be compared to both as-is building conditions and as-built drawings (should they exist). Lastly, building component geometry can be used to build fully functional building information models (BIM) that not only provide accurate dimensions of the as-is building, but precise locations of the building's components.

Figure 1: Steps For Creating a BIM Model from A Laser Scan
