Upgrading the Wyoming State Capitol's Mechanical System: A Case Study

Anna Simpkins, M.S., John Killingsworth, Ph.D., and Jon Elliott, Ph.D.
Colorado State University
Fort Collins, Colorado

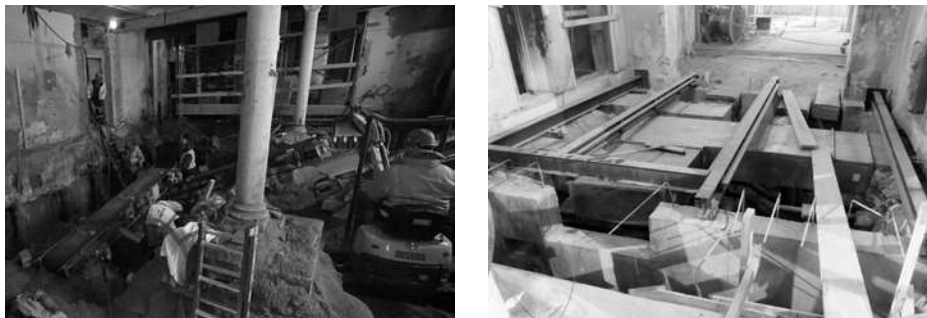
Figure 2: Below-slab micropile installation, ductwork and piping, March 2018

The mechanical design was carefully coordinated with the structural engineering and architectural teams to accommodate required structural improvements while disguising mechanical systems and retaining and recreating historic features. Two of the largest structural interventions included rebuilding four shear walls from the original 1880 core and drilling 450 micropiles into bedrock below the entire Capitol Building. Mechanical systems were designed around these interventions (see figure 2). Garden level ductwork and hydronic piping runs below the slab and all MEP components had to be designed around the new micropiles since they were specifically placed for structural loads. The garden level had to be excavated six additional feet below the top of the slab to install the mechanical systems (Foder, 2018).

The majority of horizontal ductwork and mechanical piping is encased below the slab under the garden level and in the attic, leaving the historically significant spaces free from intrusion. The new piping placed below the slab is not accessible. The mechanical engineering team insisted that the system must be jacketed and should therefore “have a lifespan adequate to prevent its deterioration and required replacement until the next major renovation” (Galway,

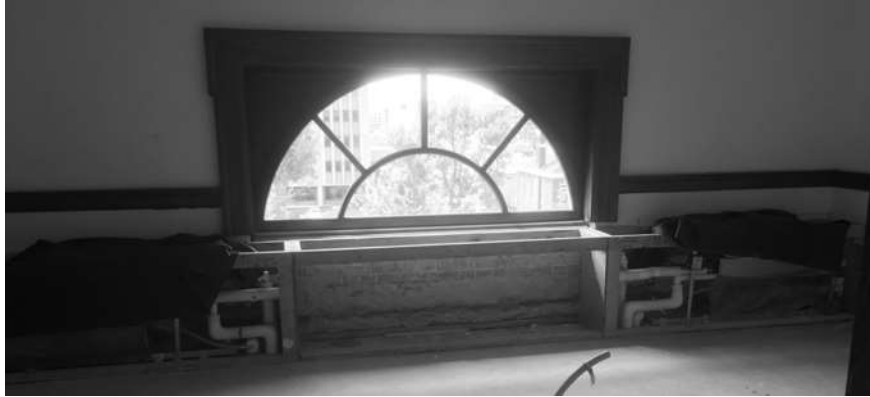
The new system utilizes steam for heating and chilled water for cooling and has 181 fan coil units in individual offices. The fan coils are individually regulated constant volume units (Galway, 2018) that were disguised in smaller offices and meeting rooms within decorative built-in woodwork to enhance the building's character and protect the equipment (figure 3).

Figure 3: Fan coil units framed for built-in decorative woodwork.
